**HAZARDOUS MINE OPENING
MAINTENANCE PROJECT
DSL/AMRB PROJECT NO. 93-M08**

HAZARDOUS MINE OPENING MAINTENANCE PROJECT
DSL/AMRB PROJECT NO. 93-M08

July 1994

RE: Hazardous Mine Opening Maintenance Project - Final Report

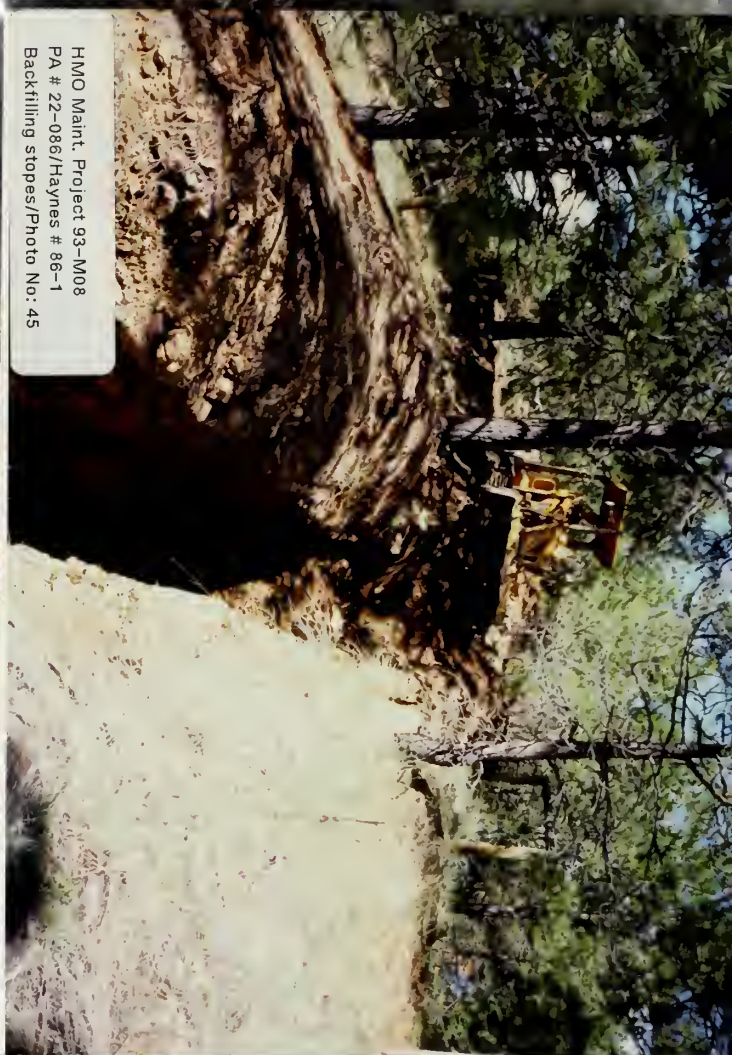
HMO Maint. Project 93-M08
PA # 22-086/Haynes # 86-1
Backfilling slopes/Photo No: 45

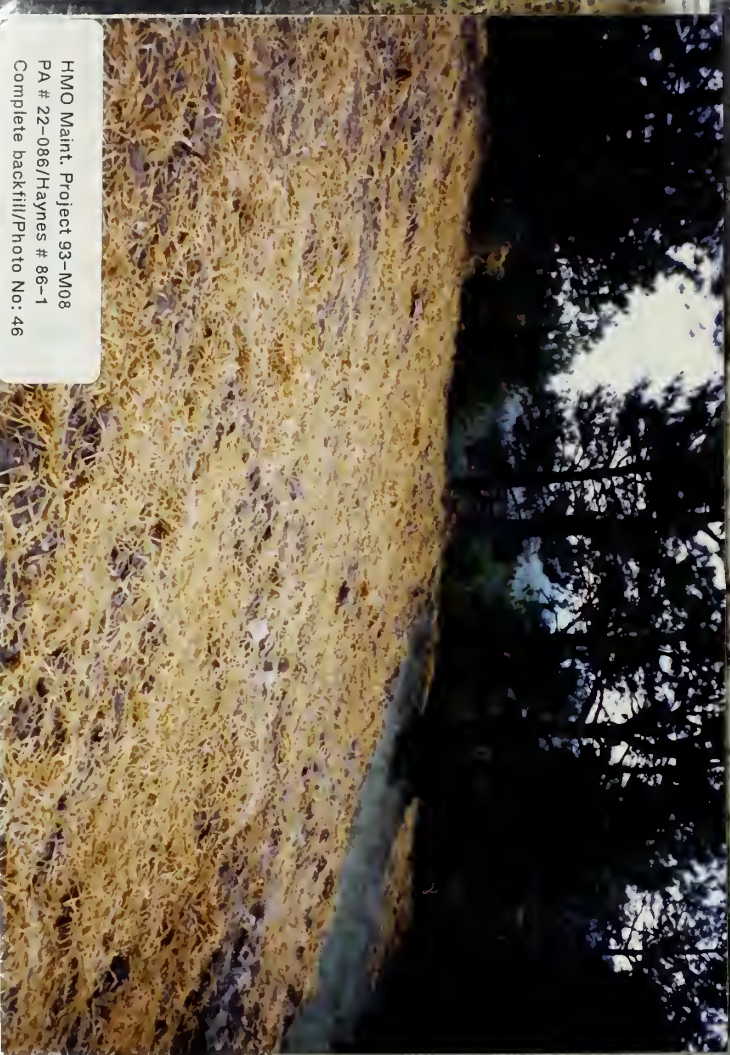
HMO Maint. Project 93-M08
PA # 22-086/Haynes # 86-1
Complete backfill/Photo No: 46

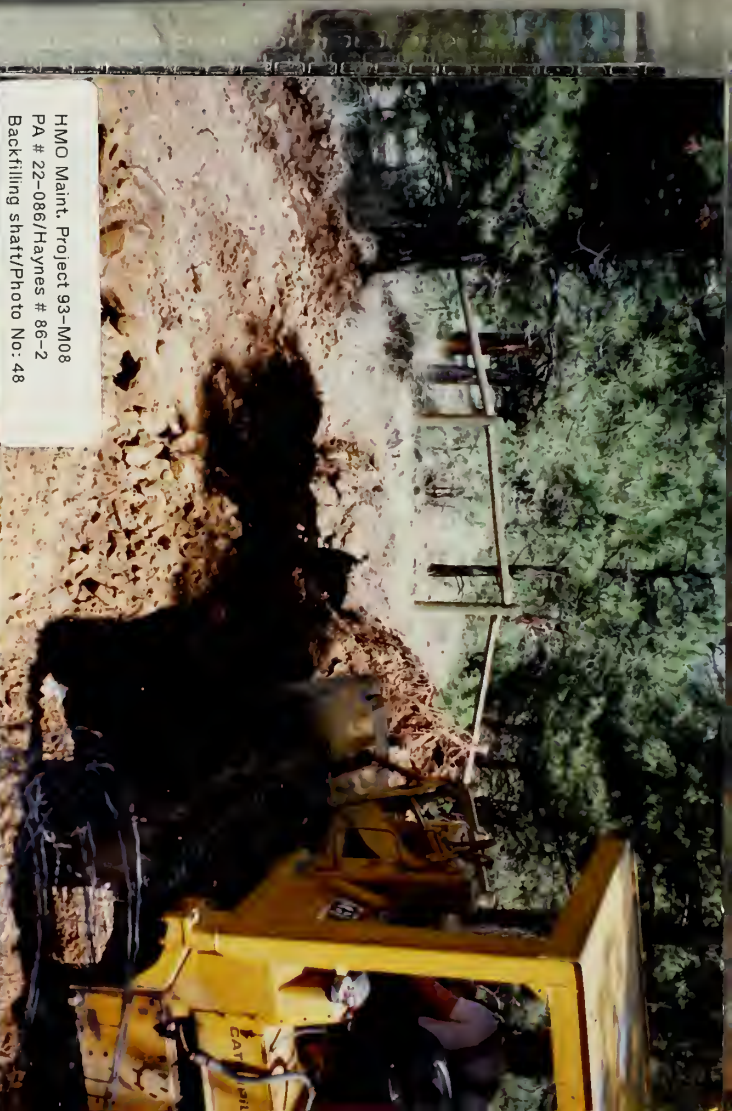
HMO Maint. Project 93-M08
PA # 22-086/Haynes # 86-2
Backfilling shaft/Photo No: 48

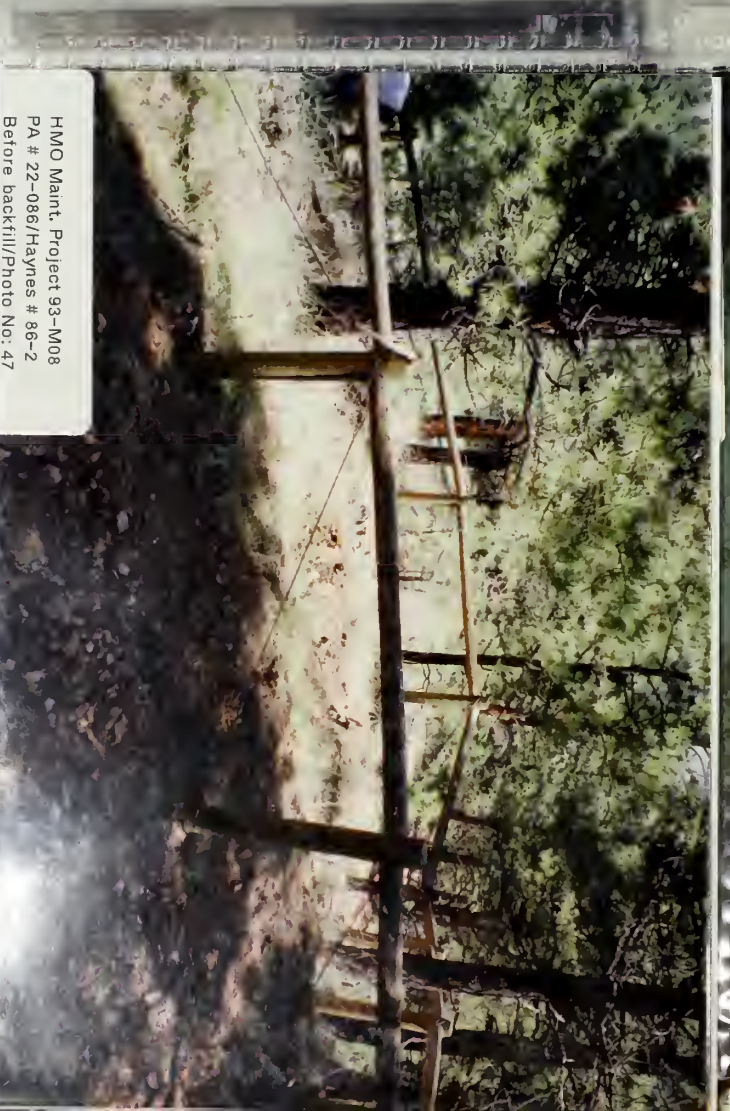
HMO Maint. Project 93-M08
PA # 22-086/Haynes # 86-2
Before backfill/Photo No: 47

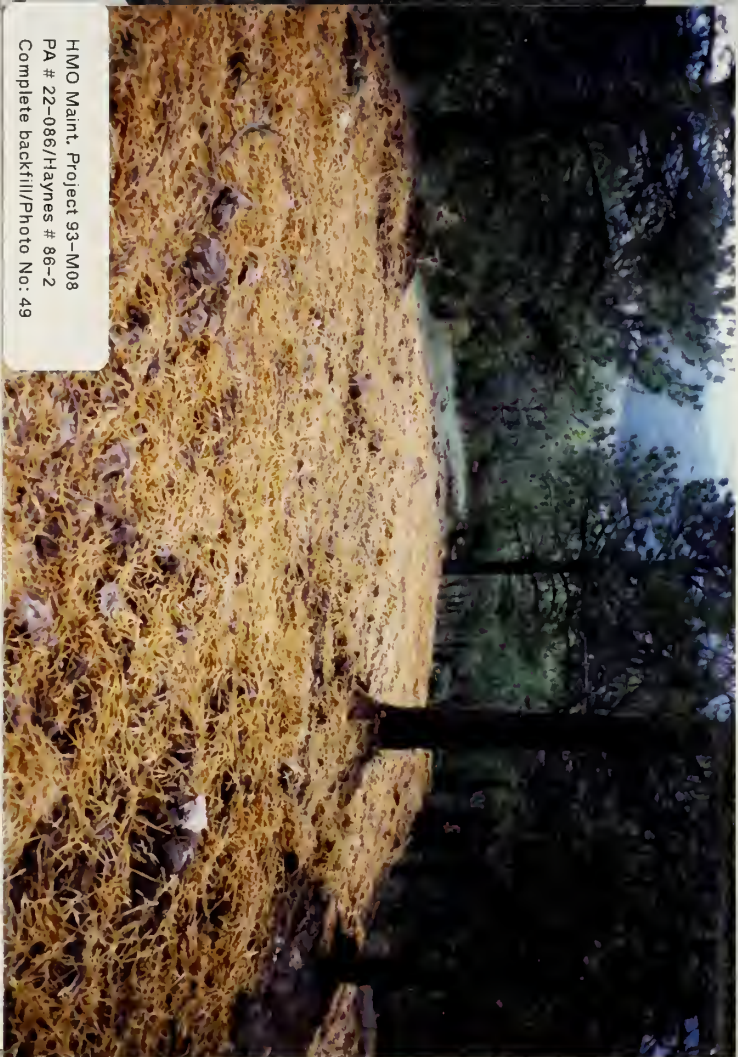
HMO Maint, Project 93-M08
PA # 22-086/Haynes # 86-2
Complete backfill/Photo No: 49

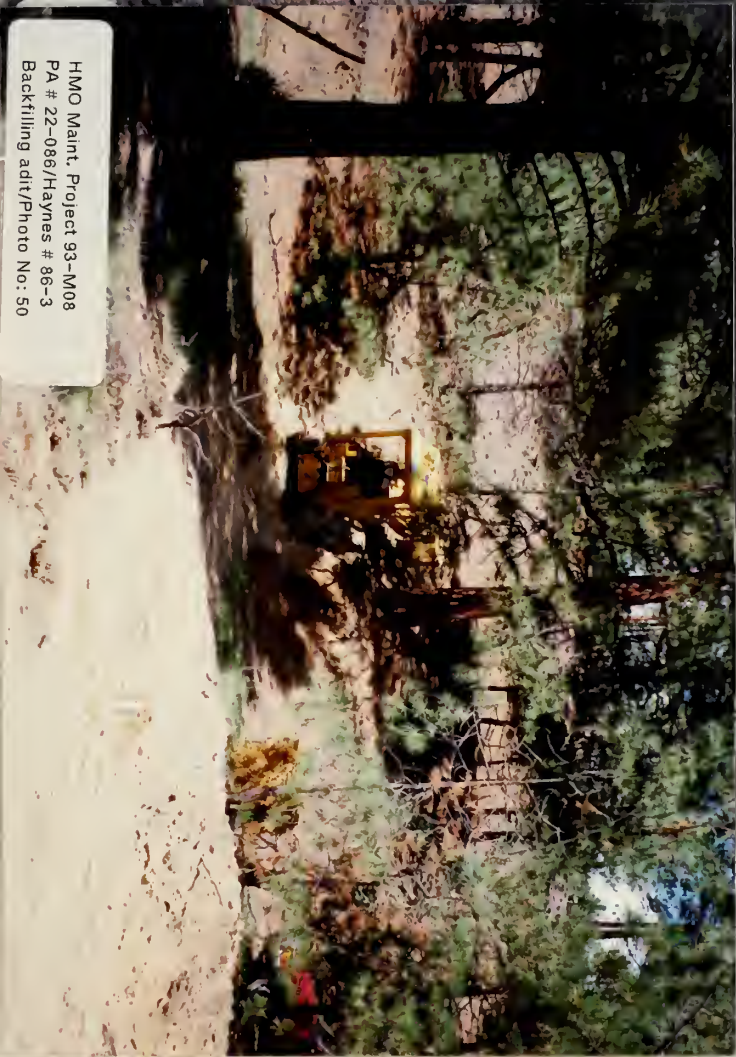
HMO Maint, Project 93-M08
PA # 22-086/Haynes # 86-3
Backfilling adit/Photo No: 50

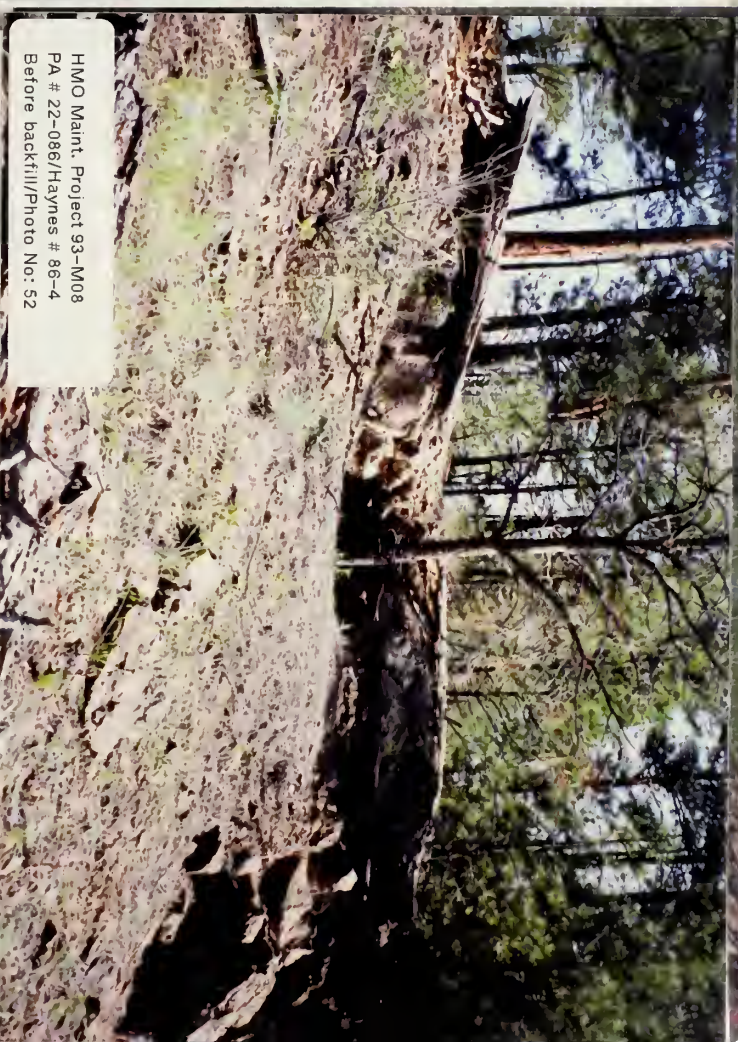
HMO Maint, Project 93-M08
PA # 22-086/Haynes # 86-4
Before backfill/Photo No: 52

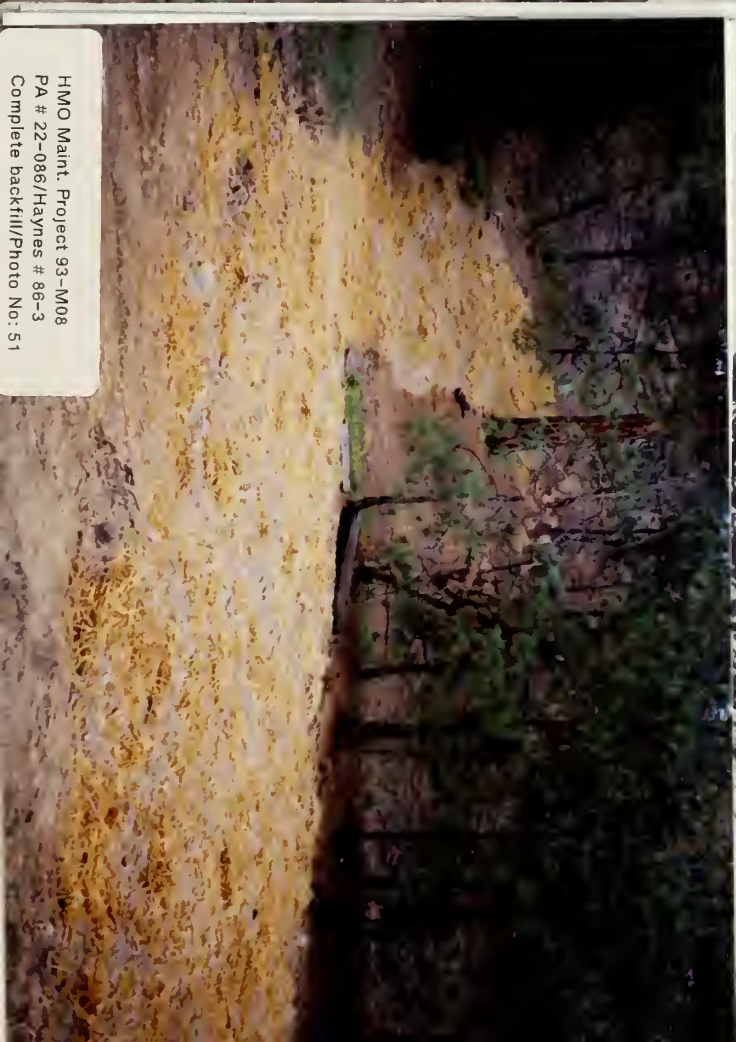
HMO Maint, Project 93-M08
PA # 22-086/Haynes # 86-3
Complete backfill/Photo No: 51

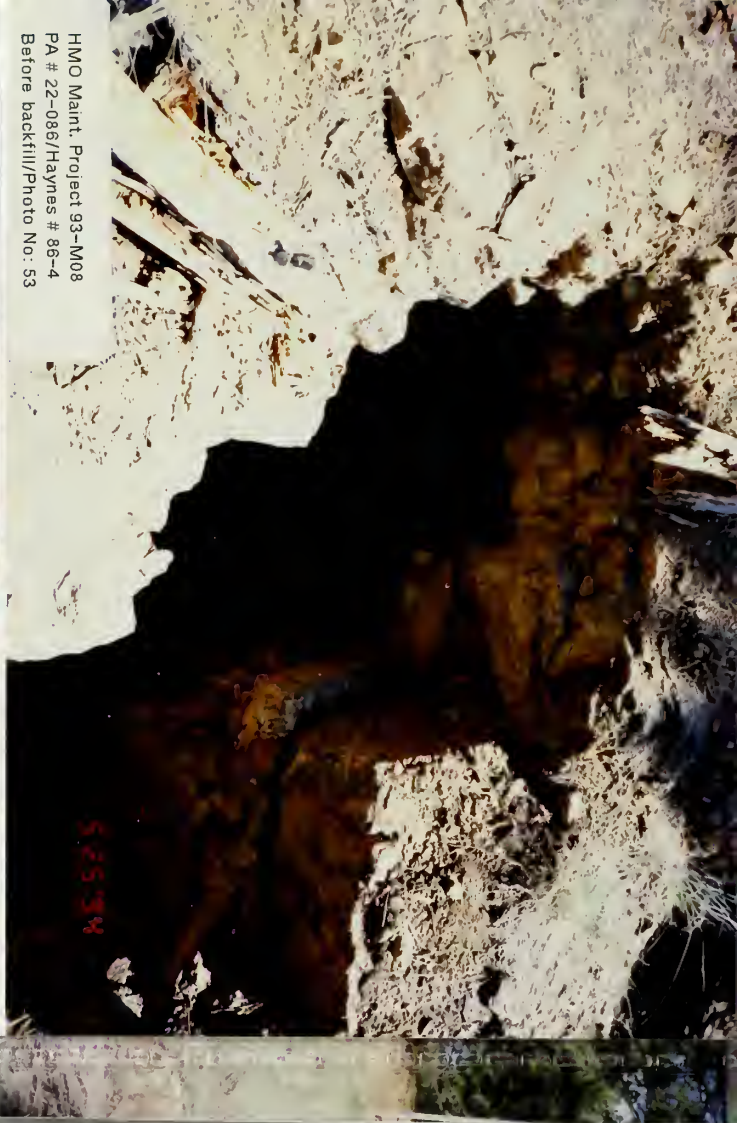
HMO Maint. Project 93-M08
PA # 22-086/Haynes # 86-4
Before backfill/Photo No.: 53

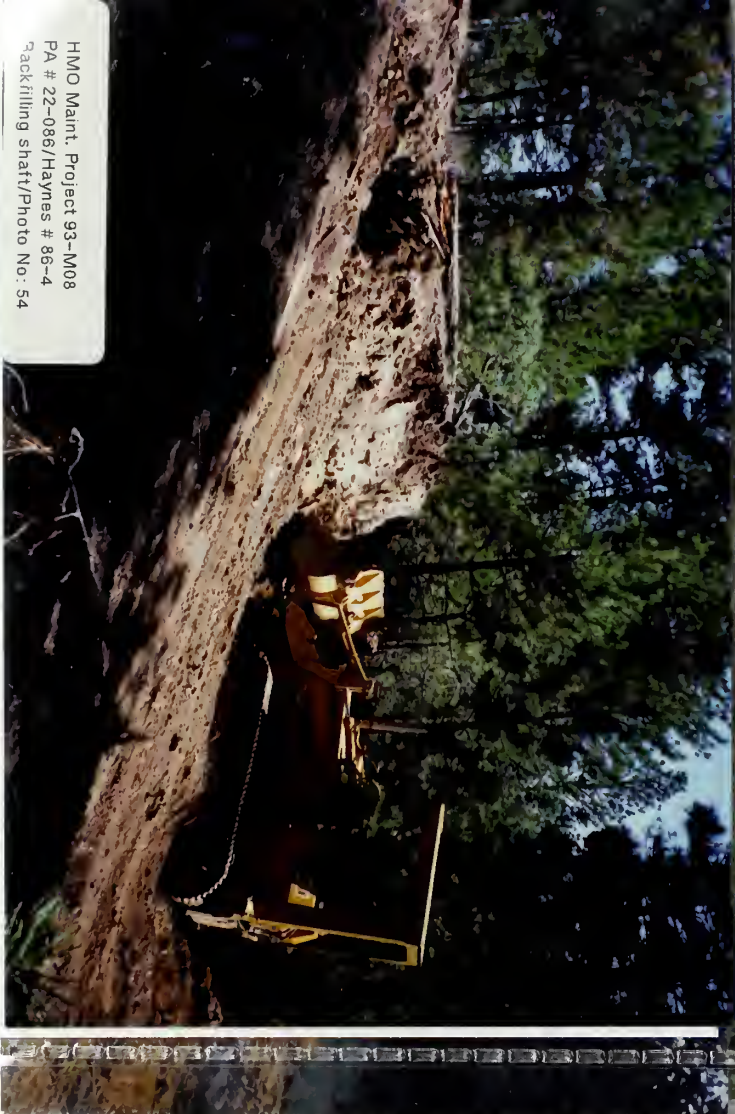
HMO Maint. Project 93-M08
PA # 22-086/Haynes # 86-4
Backfilling shaft/Photo No.: 54

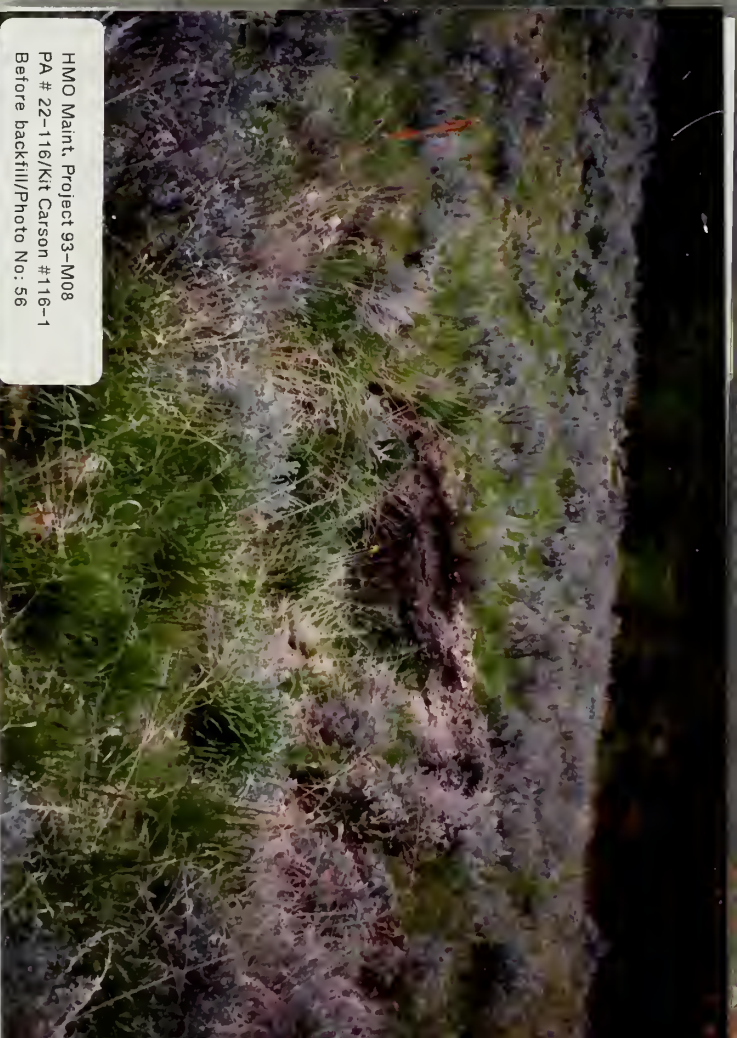
HMO Maint. Project 93-M08
PA # 22-116/Kit Carson #116-1
Before backfill/Photo No.: 56

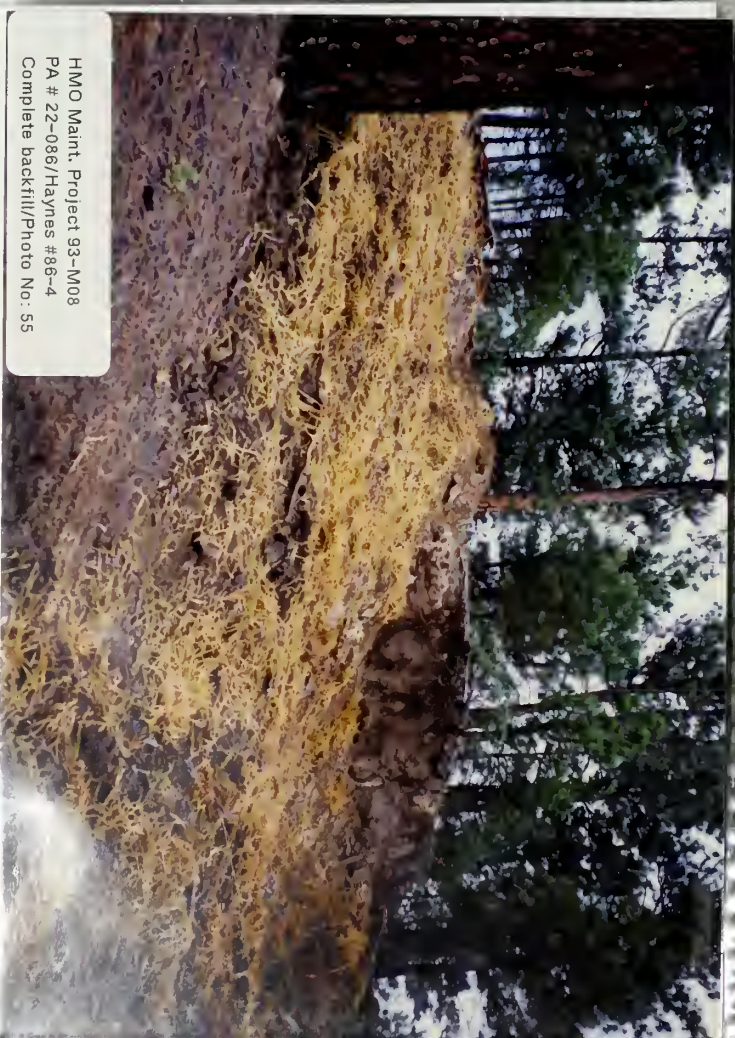
HMO Maint. Project 93-M08
PA # 22-086/Haynes #86-4
Complete backfill/Photo No.: 55

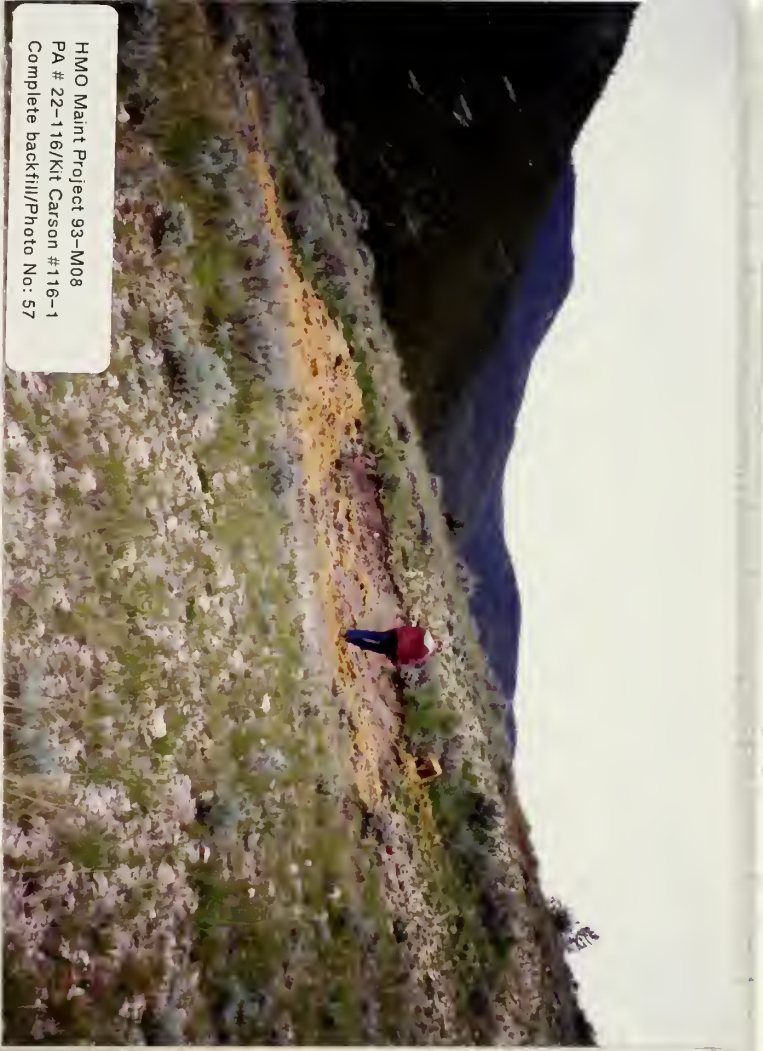
HMO Maint. Project 93-M08
PA # 22-116/Kit Carson #116-1
Complete backfill/Photo No: 57

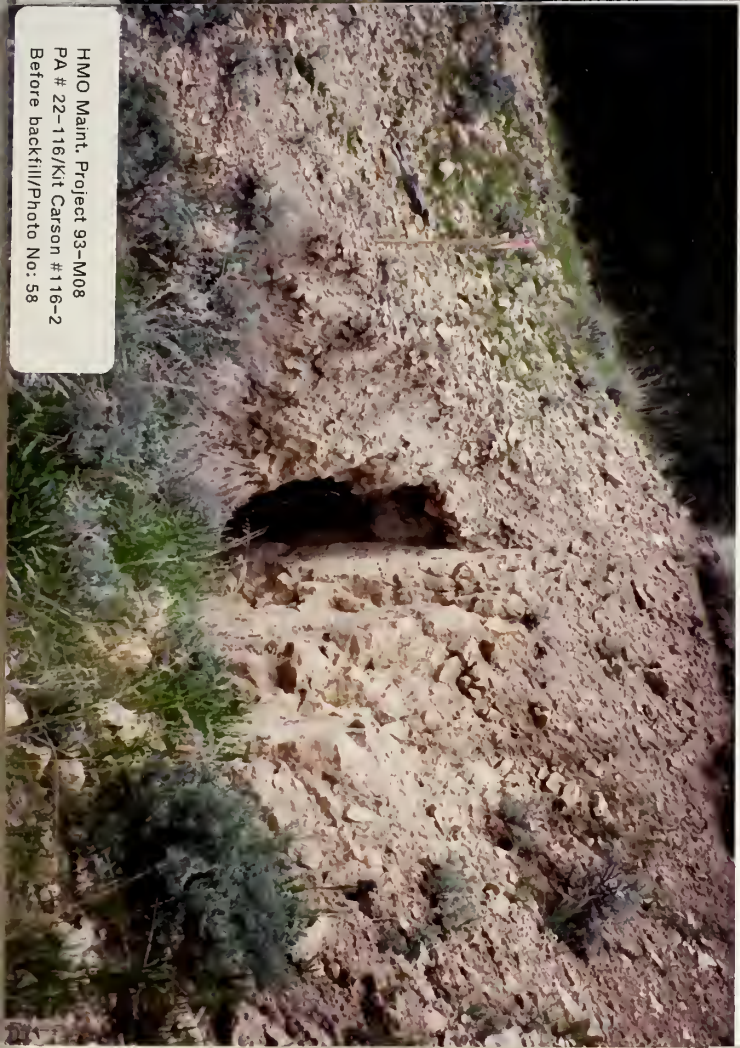
HMO Maint. Project 93-M08
PA # 22-116/Kit Carson #116-2
Before backfill/Photo No: 58

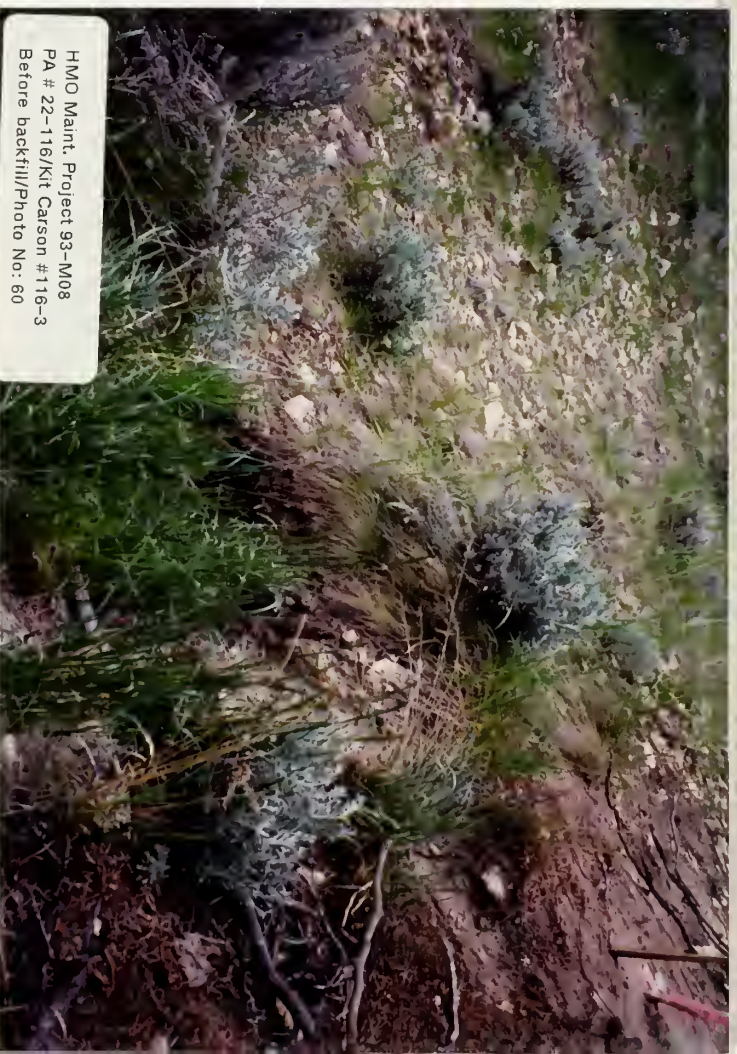
HMO Maint. Project 93-M08
PA # 22-116/Kit Carson #116-3
Before backfill/Photo No: 60

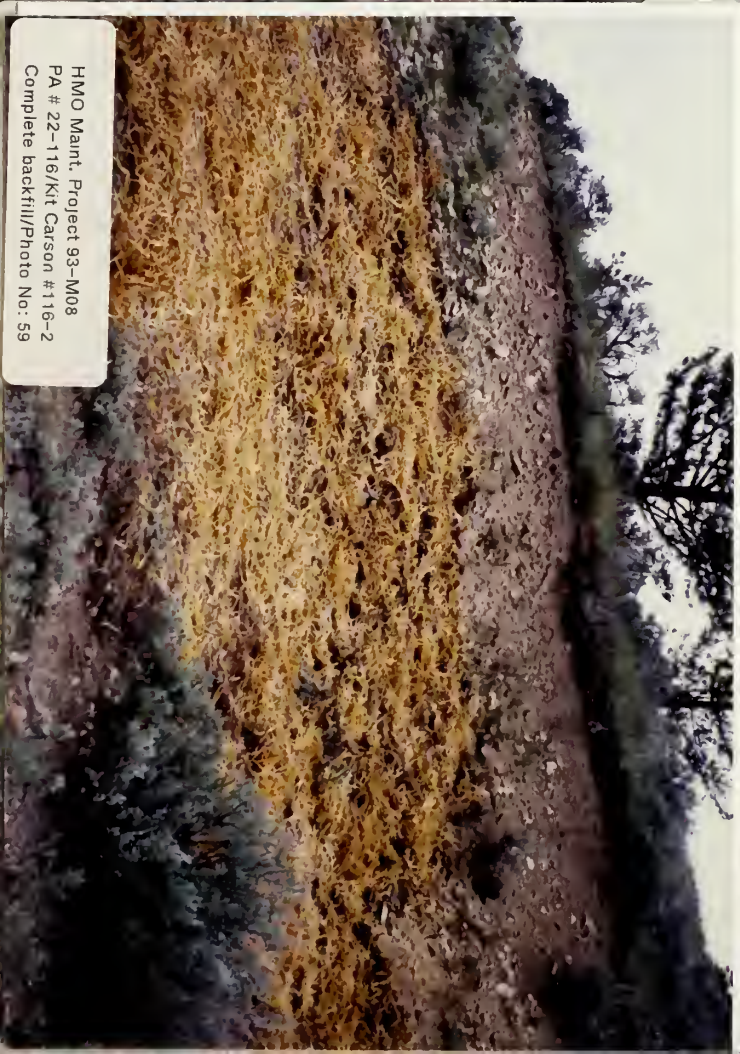
HMO Maint. Project 93-M08
PA # 22-116/Kit Carson #116-2
Complete backfill/Photo No: 59

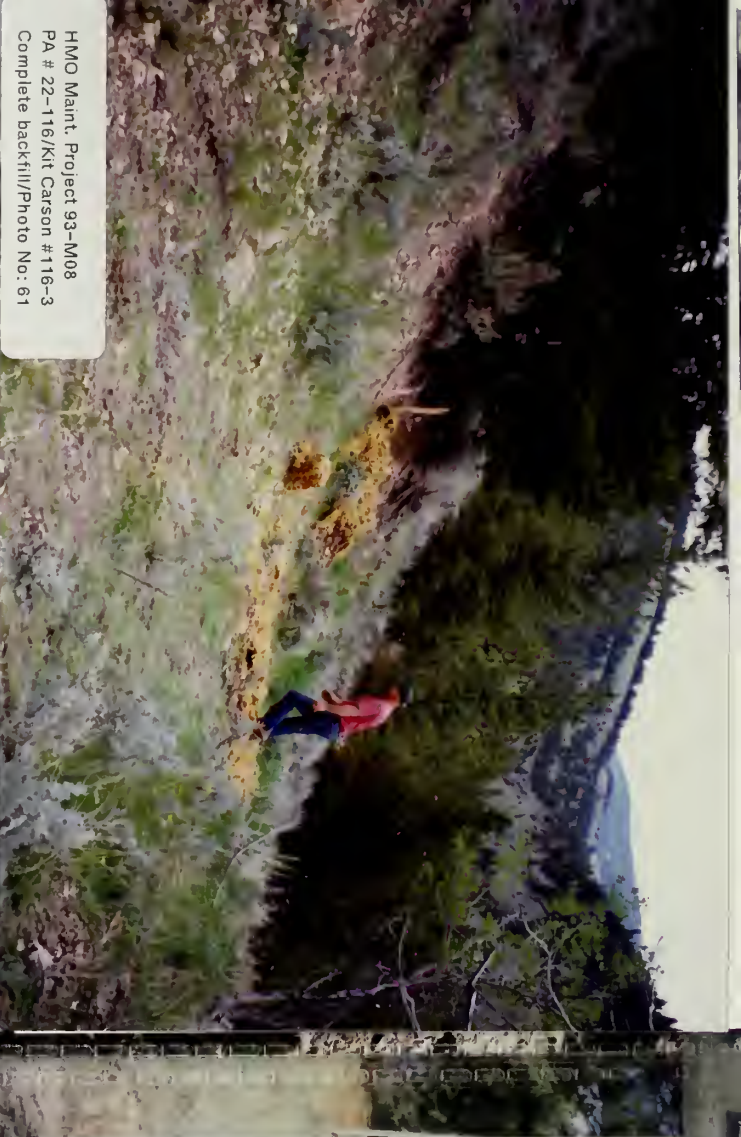
HMO Maint. Project 93-M08
PA # 22-116/Kit Carson #116-3
Complete backfill/Photo No: 61

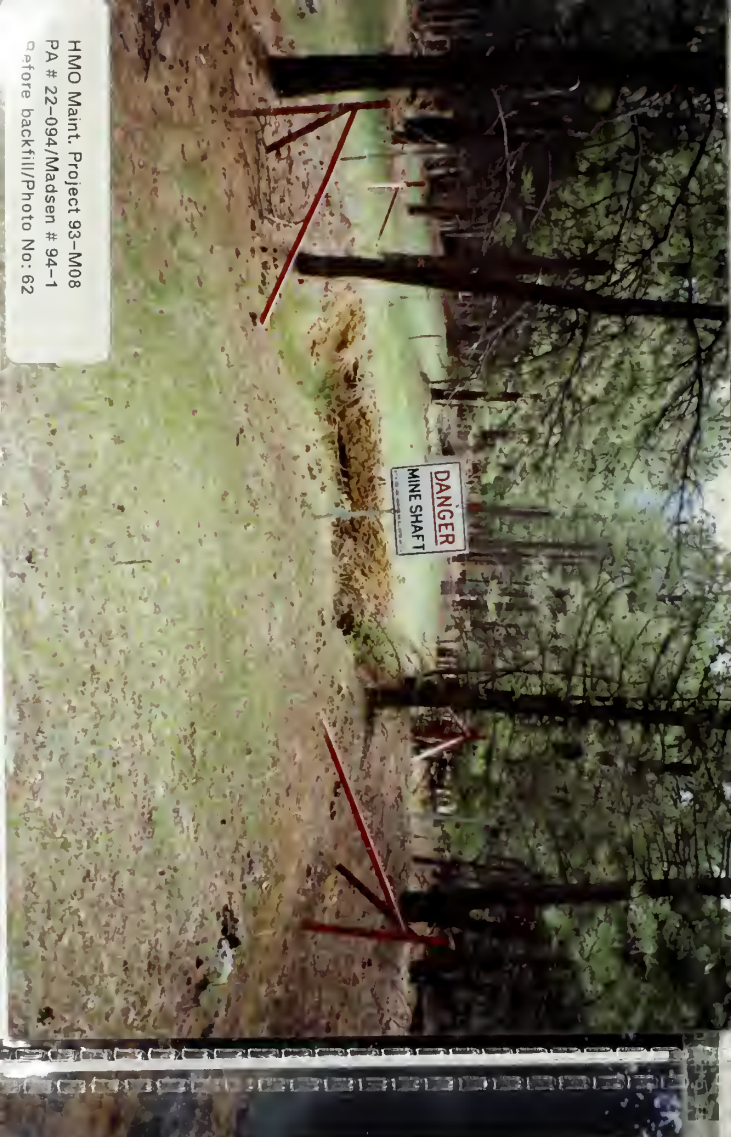
HMO Maint. Project 93-M08
PA # 22-094/Madsen # 94-1
Before backfill/Photo No: 62

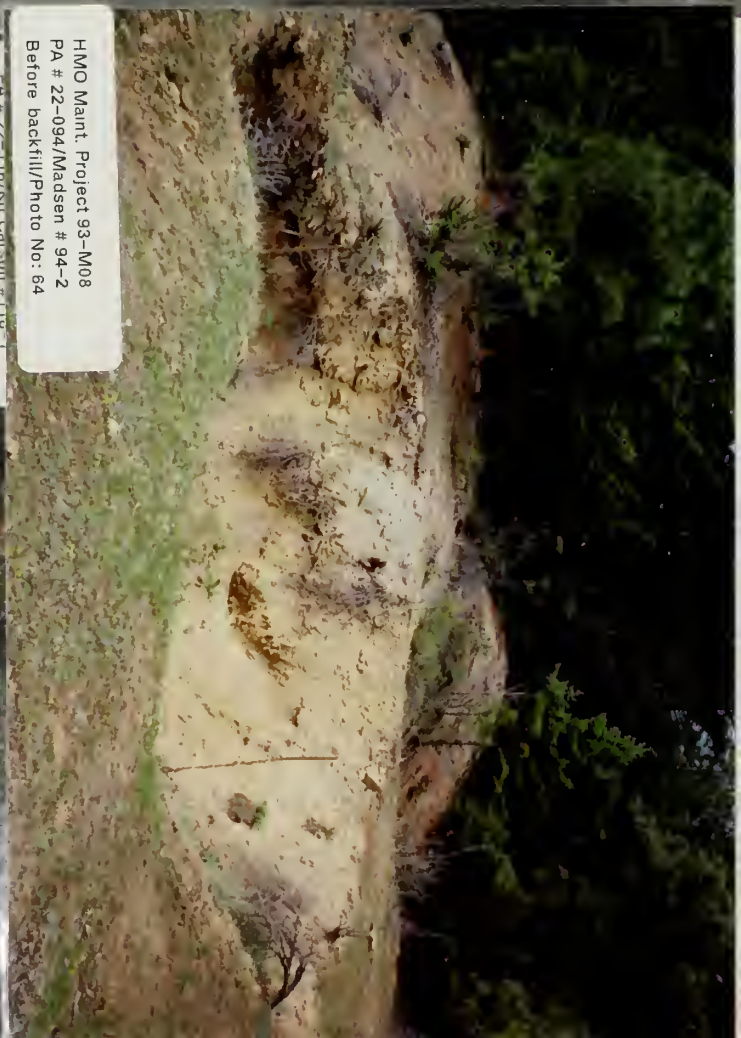
HMO Maint. Project 93-M08
PA # 22-094/Madsen # 94-2
Before backfill/Photo No: 64

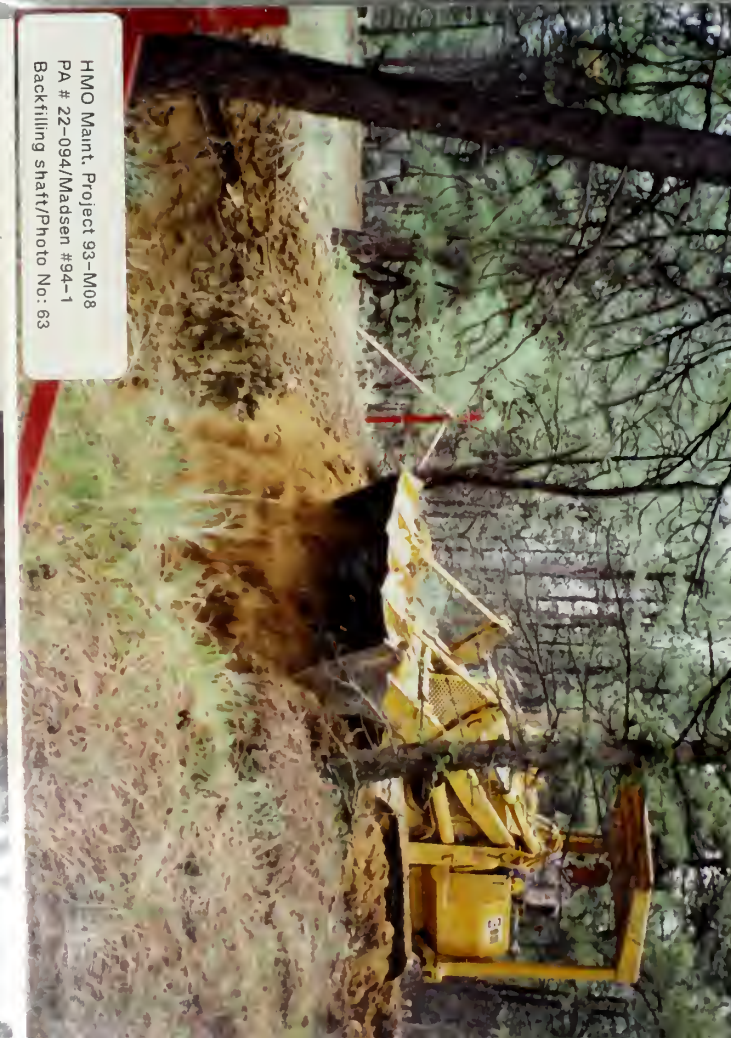
HMO Maint. Project 93-M08
PA # 22-094/Madsen #94-1
Backfilling shaft/Photo No: 63

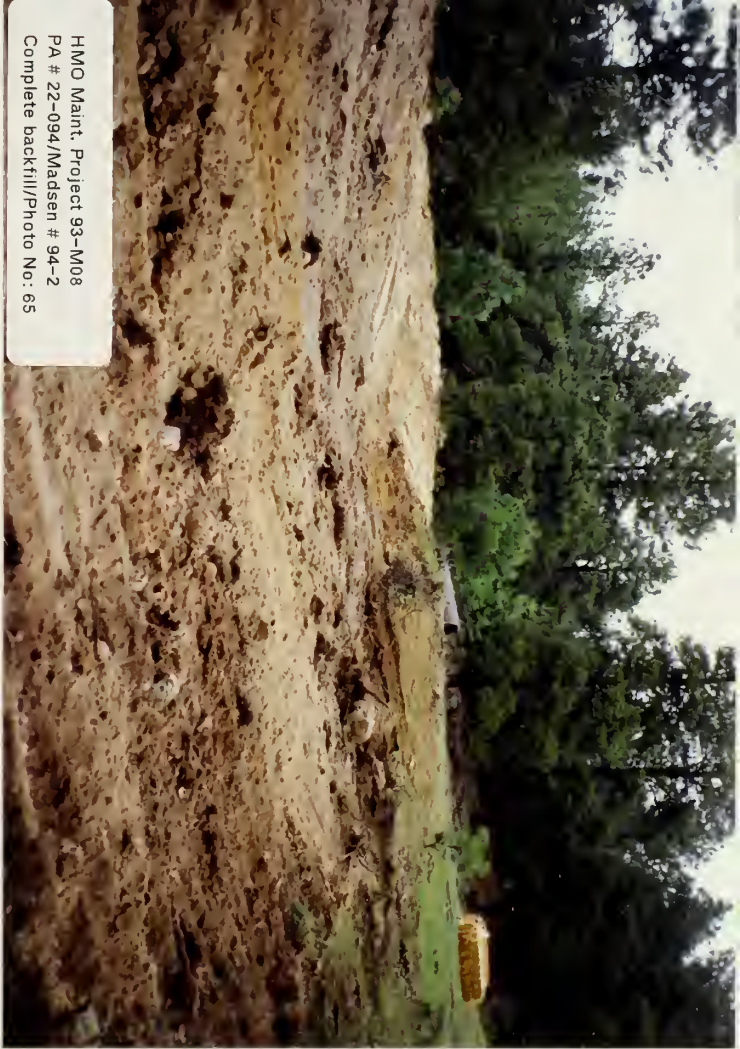
HMO Maint, Project 93-M08
PA # 22-094/Madsen # 94-2
Complete backfill/Photo No: 65

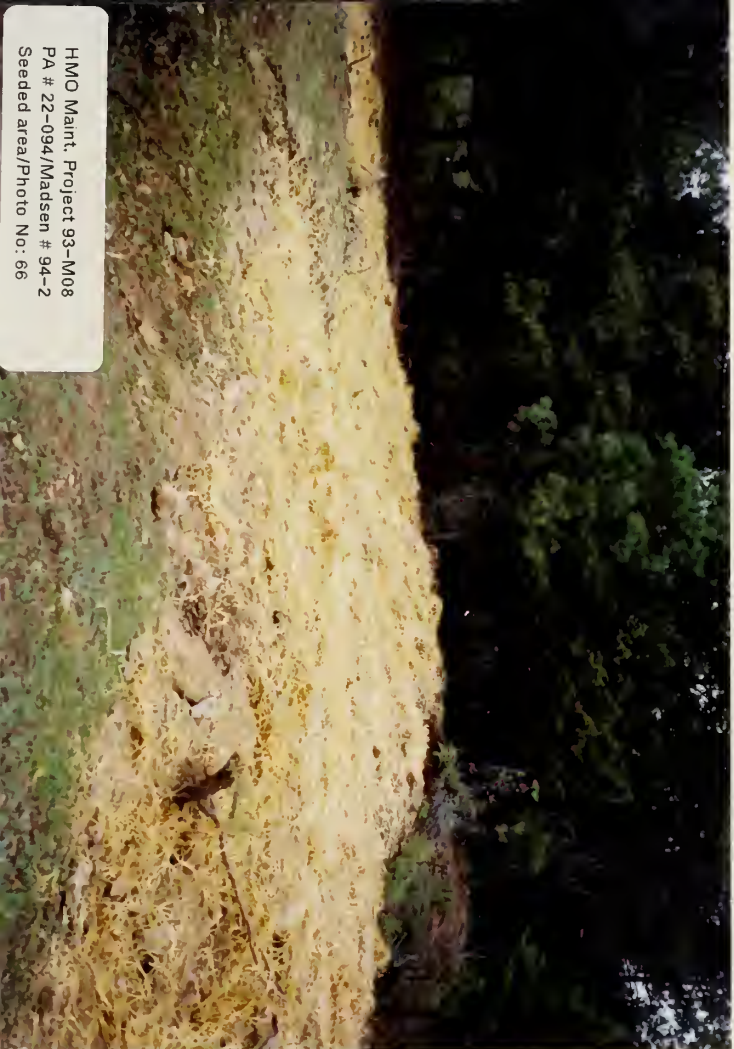
HMO Maint, Project 93-M08
PA # 22-094/Madsen # 94-2
Seeded area/Photo No: 66

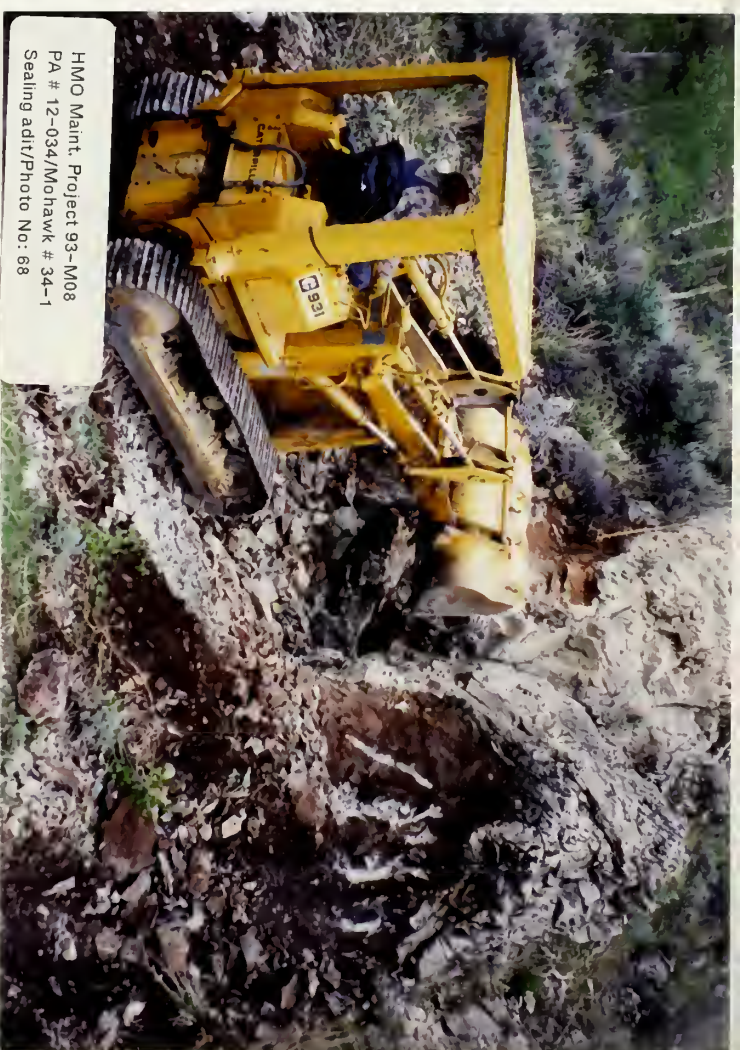
HMO Maint, Project 93-M08
PA # 12-034/Mohawk # 34-1
Sealing adit/Photo No: 68

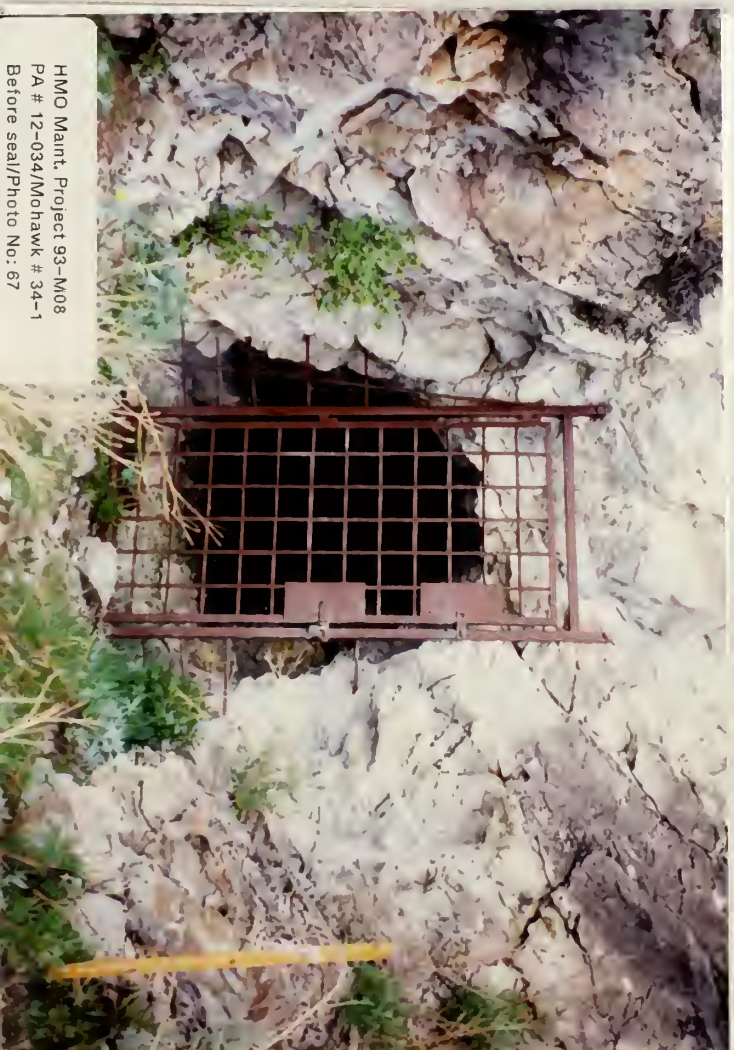
HMO Maint, Project 93-M08
PA # 12-034/Mohawk # 34-1
Before seal/Photo No: 67

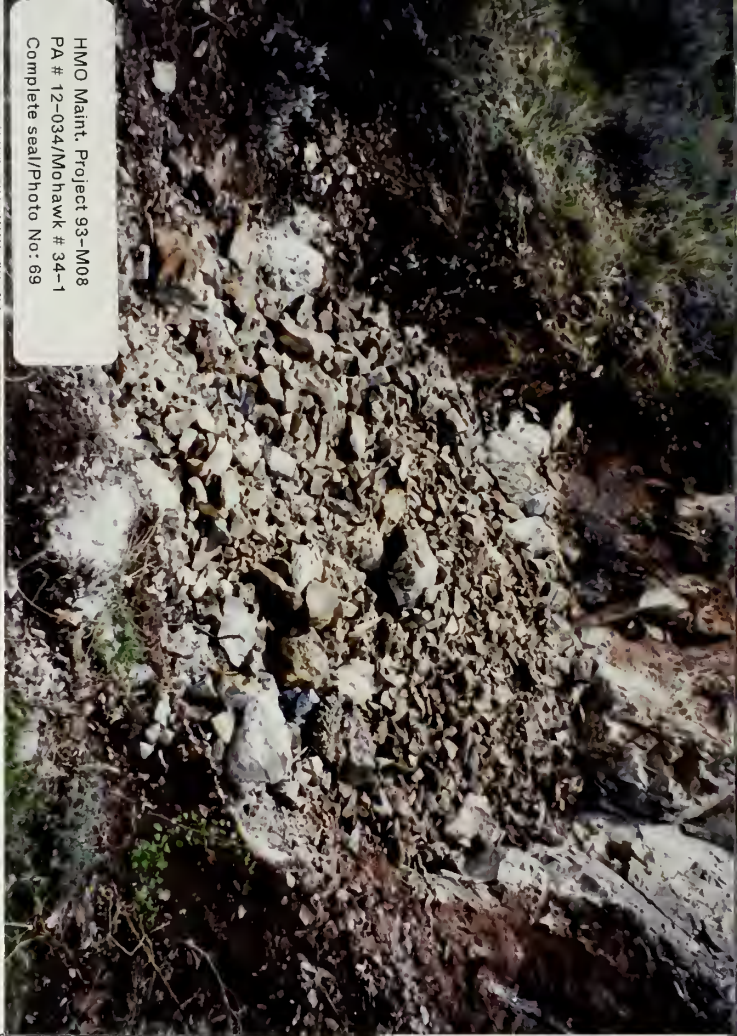
HMO Maint. Project 93-M08
PA # 12-034/Mohawk # 34-1
Complete seal/photo No: 69

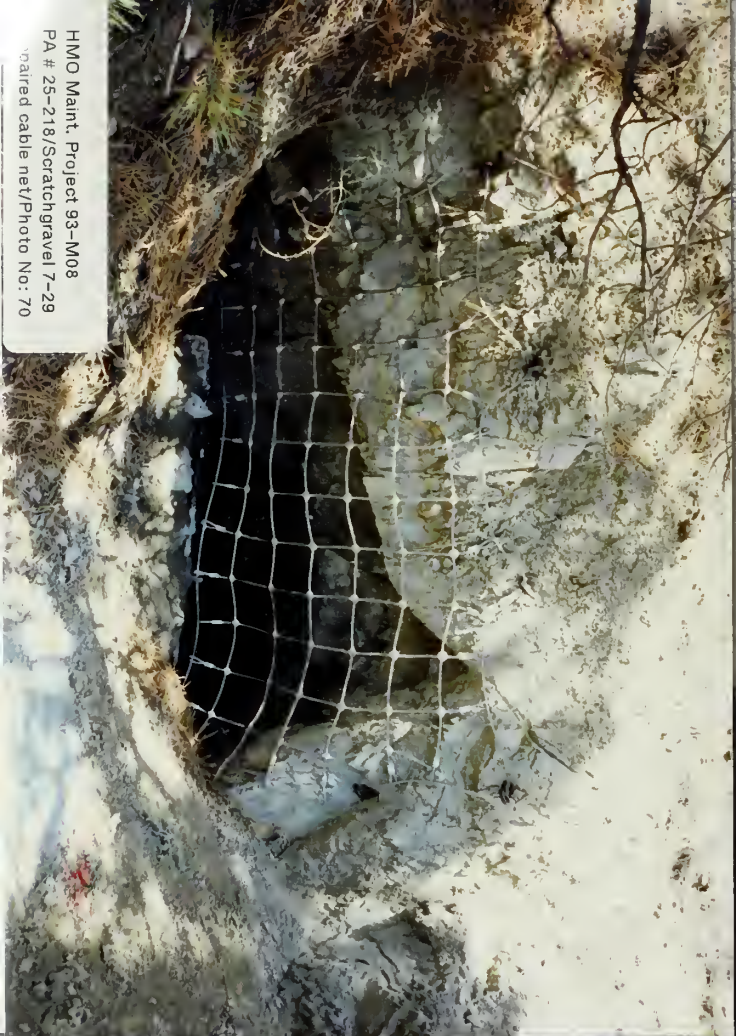
HMO Maint. Project 93-M08
PA # 25-218/Scratchgravel 7-29
Repaired cable net/photo No: 70

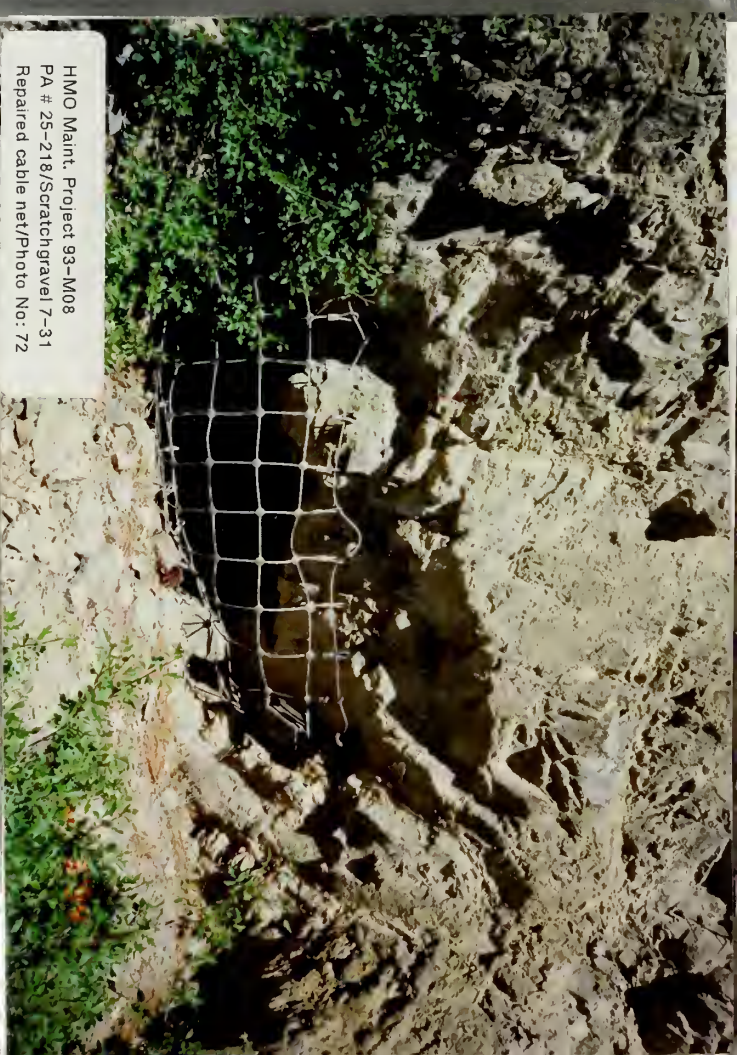
HMO Maint. Project 93-M08
PA # 25-218/Scratchgravel 7-31
Repaired cable net/photo No: 72

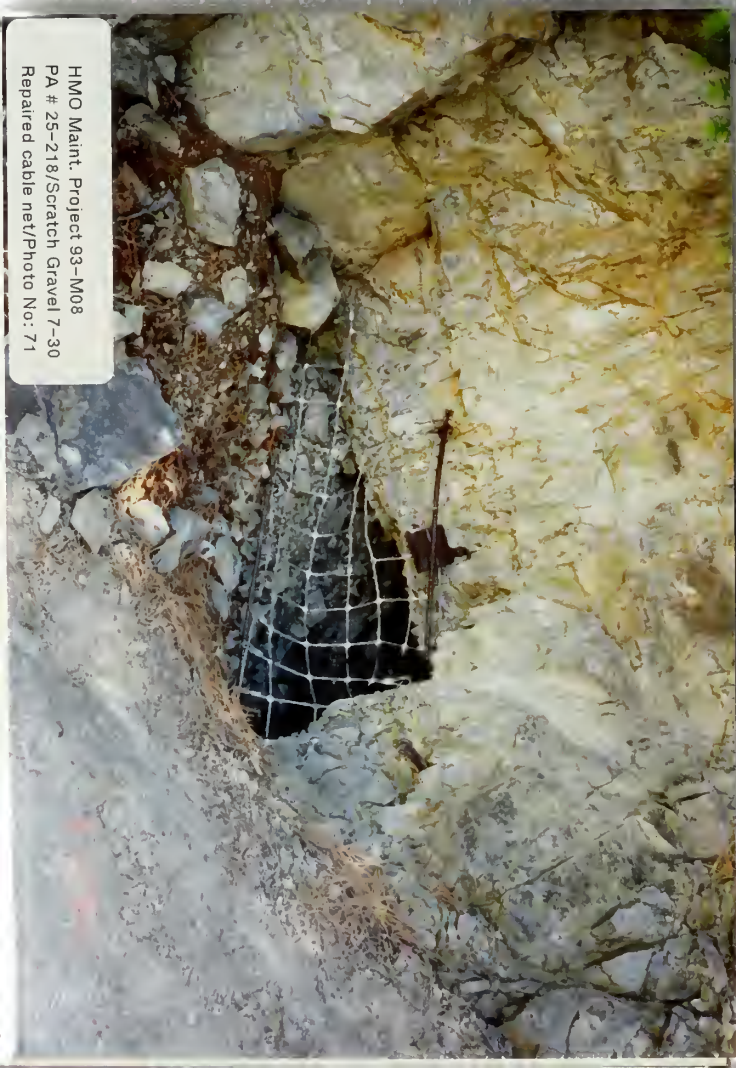
HMO Maint. Project 93-M08
PA # 25-218/Scratch Gravel 7-30
Repaired cable net/photo No: 71
